Centre Pivot performance on dairy pastures – How efficient?

Scott Carlson, Richard Rawnsley, Daniel Donaghy and Lucy Burkitt

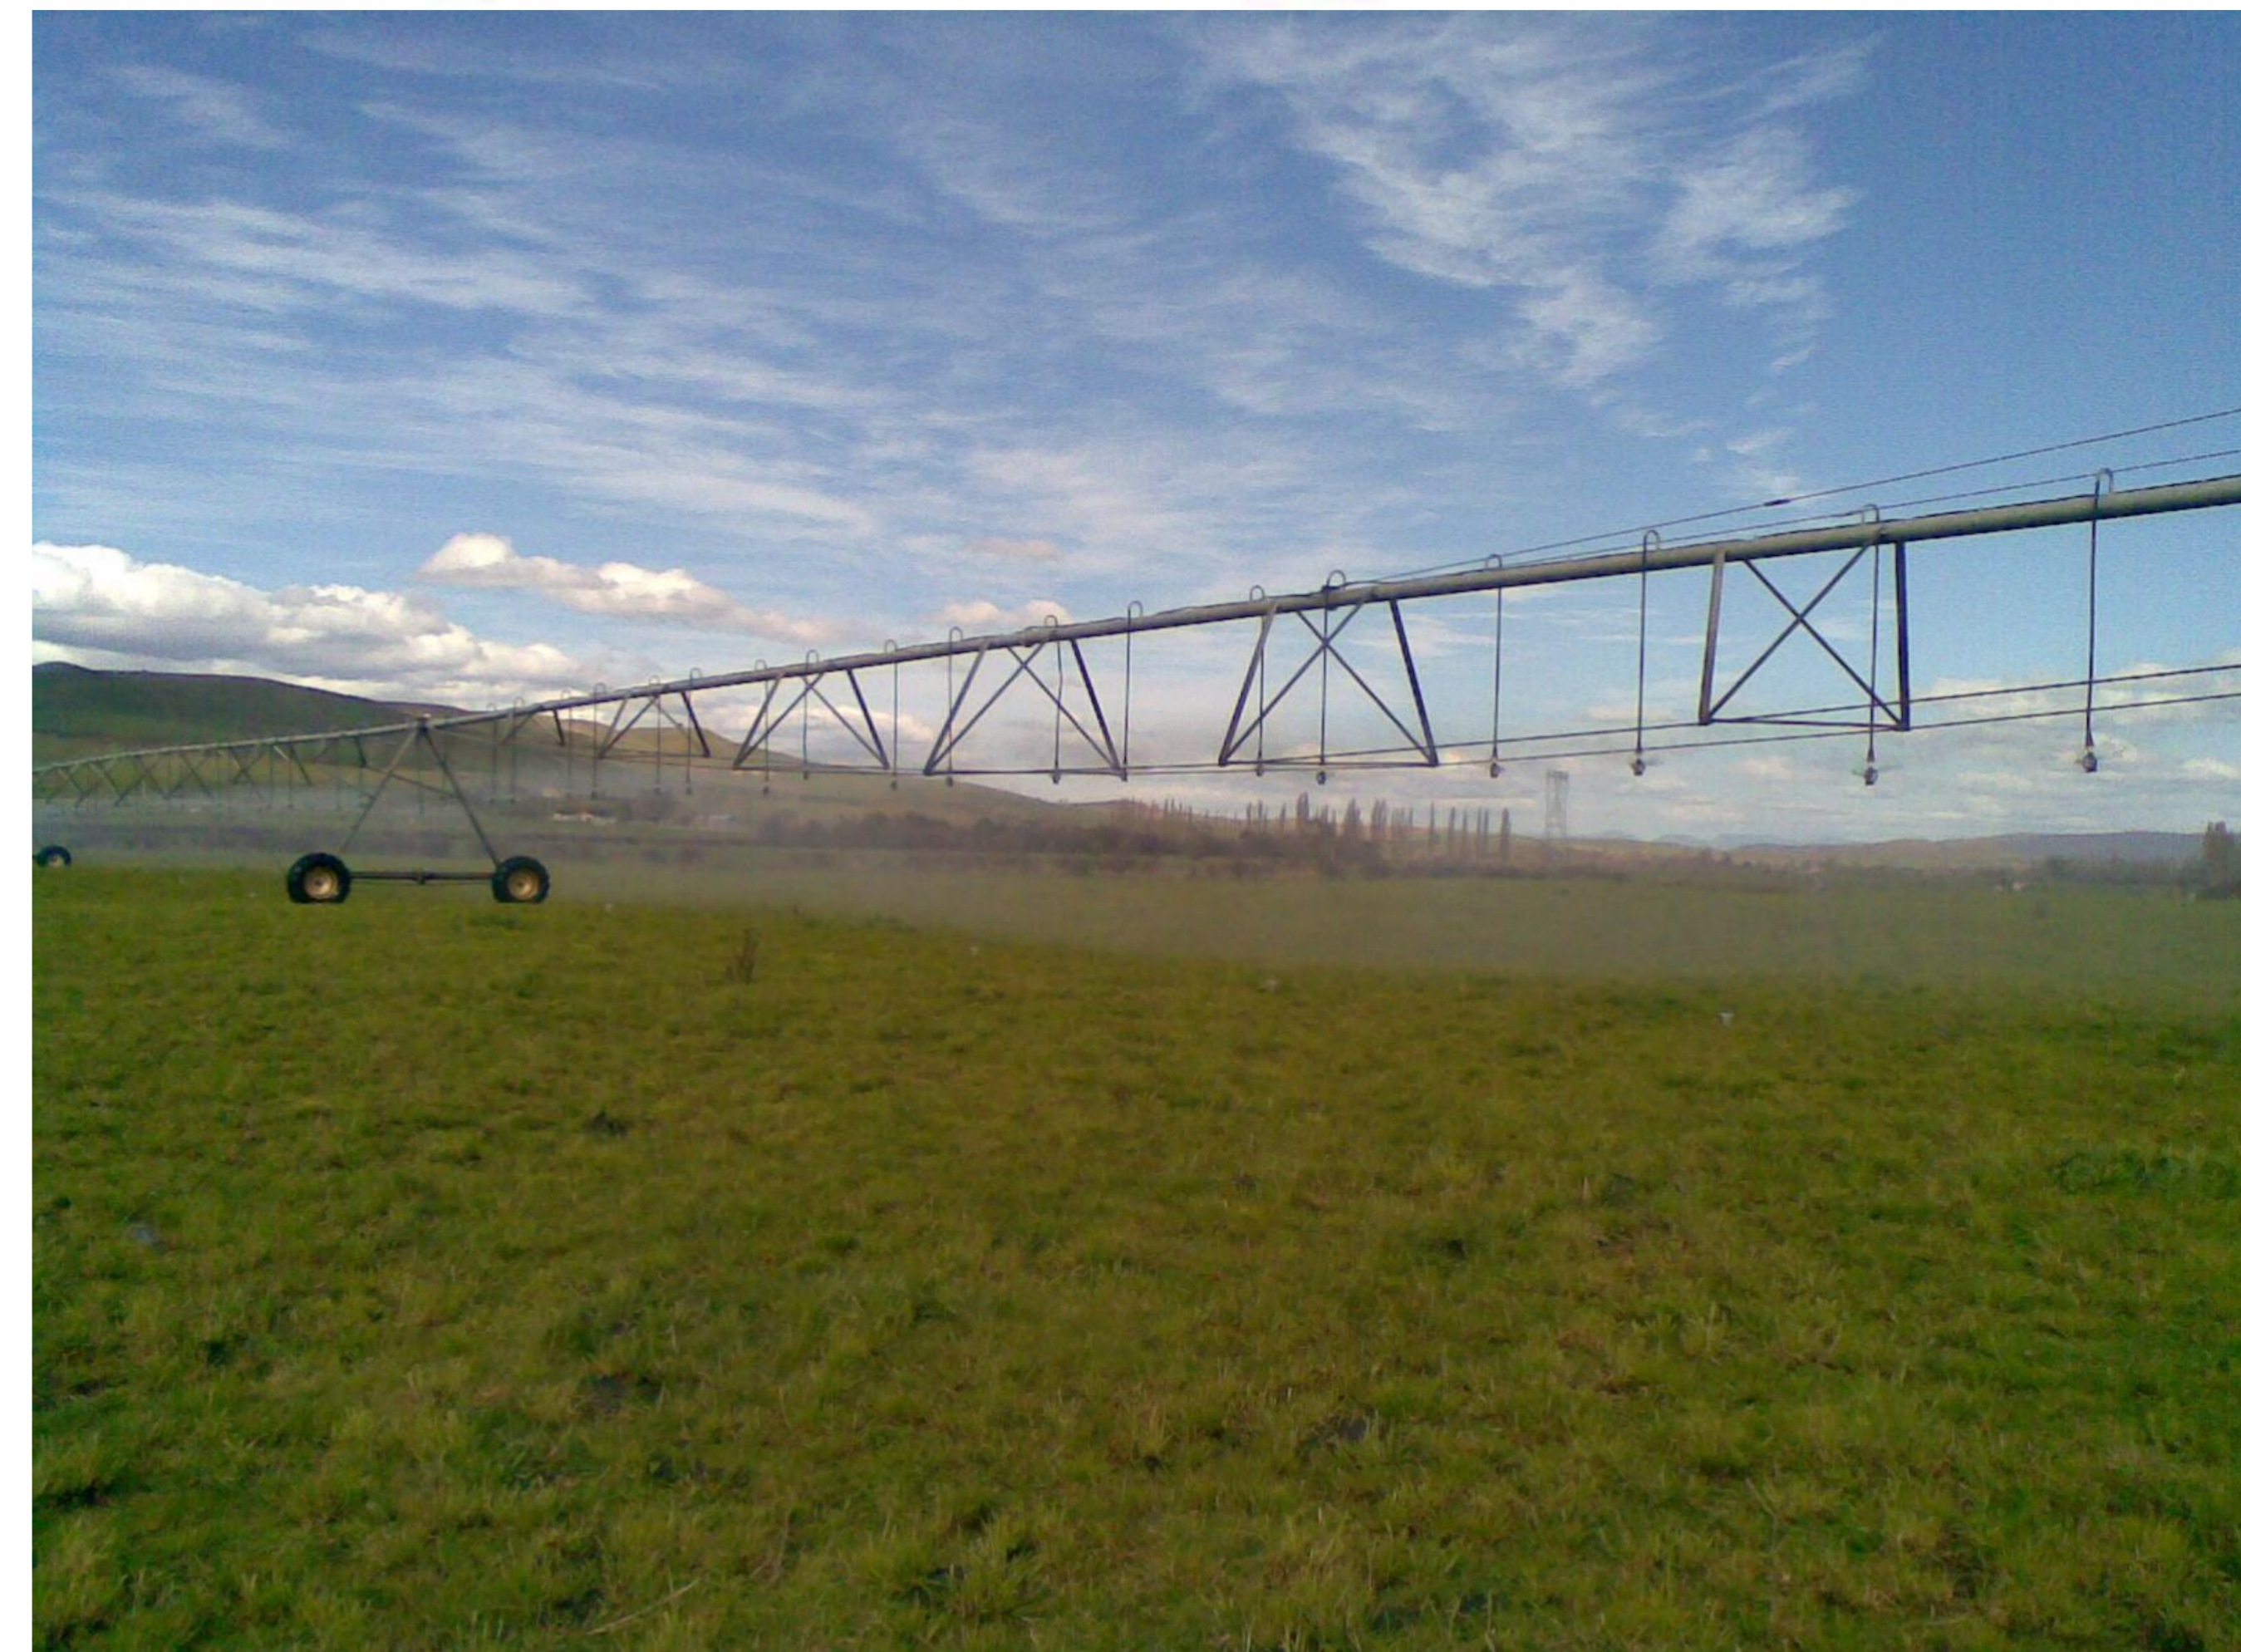
Plate 1. Measuring the distribution uniformity (DU) of centre pivot irrigator

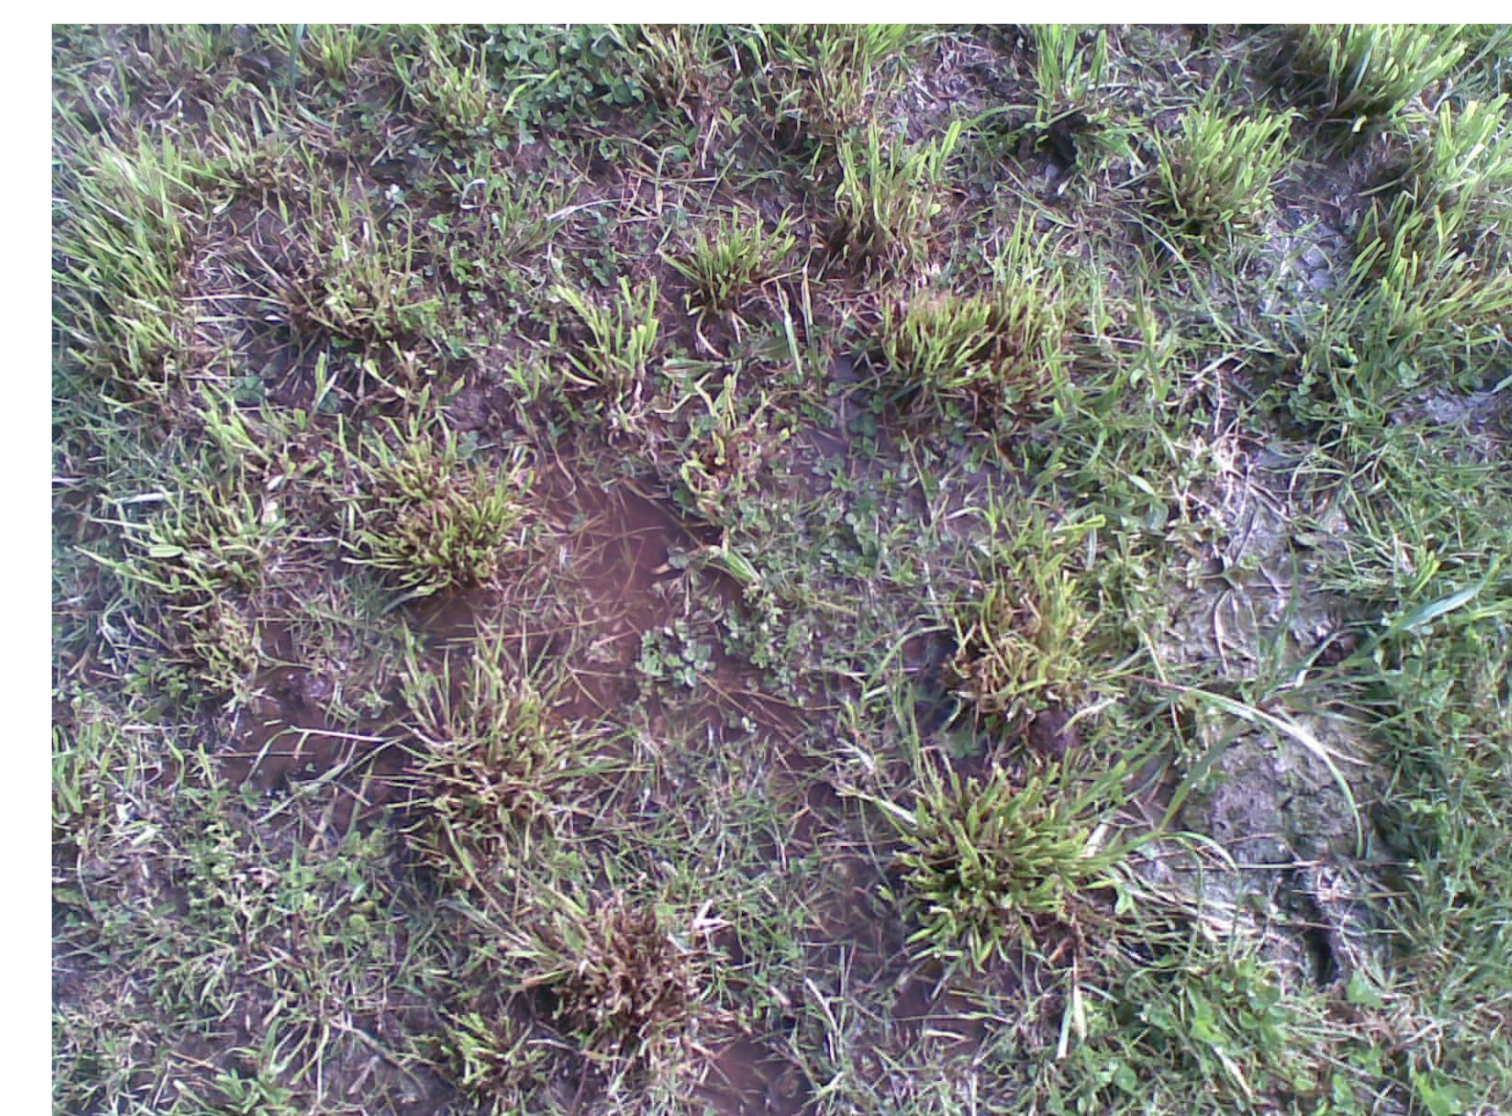
- ❑ The distribution uniformity was slightly below what was expected and irrigation application rate was found to be excessive (> 70 mm/hr) on the outer spans of the larger pivots (Plate 2).
- ❑ For further information contact Scott Carlson at TIAR.
Scott.Carlson@utas.edu.au

Plate 2. Soil surface ponding due to excessive irrigation application rates.
